## **RESTORATION OF CROWN FRACTURES WITH A FIBER POST, POLYETHYLENE FIBER AND COMPOSITE RESIN: a combined restorative technique with two case reports**

**OBJECTIVE:** To describe the treatment of two patients who had horizontal crown fractured maxillary incisors a few years after endodontic treatment. **METHOD:** The 23 and 19-year-old male patients presented to Atatürk University Dentistry Faculty with complex crown fractures. The treatment included a glass fiber reinforced root canal post, a fiber ribbon core and restoration with a universal resin composite. **RESULTS AND CONCLUSION:** The one-year follow-up examinations showed that the restorations were still in place and successful.

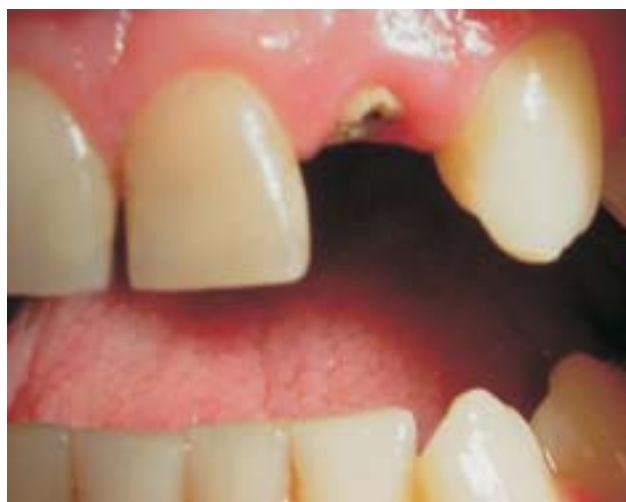
A 23-year-old male patient presented to Atatürk University Dentistry Faculty, Erzurum, Turkey, with an esthetic complaint regarding a maxillary lateral incisor. His dental history revealed that an accident caused a coronal tooth fracture of his left maxillary lateral incisor. A prosthetic crown with a metal post core was applied after endodontic treatment. However, the restoration failed after two years. After clinical and radiographic examinations, it was diagnosed a fractured maxillary lateral incisor. (Figures 1 and 2).

FIGURE 1 - Clinical aspect of fractured maxillary lateral incisor

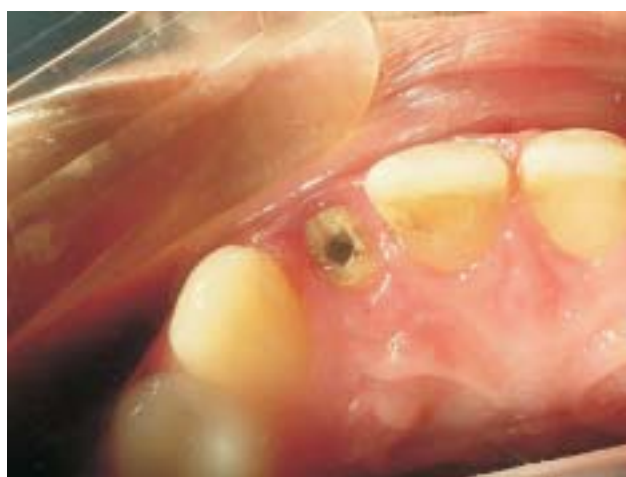
FIGURE 2 - Occlusal view of the crown fracture

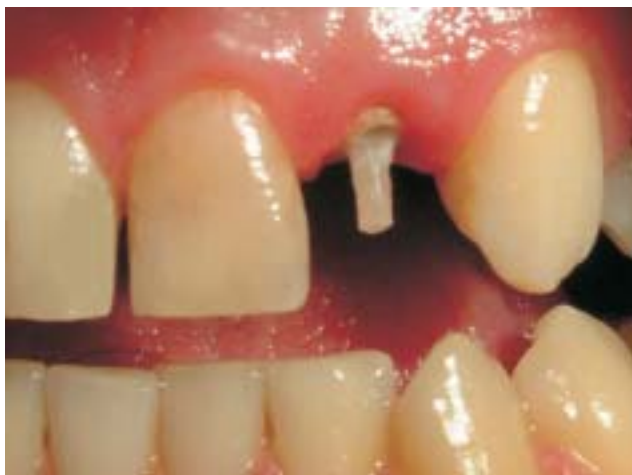
FIGURE 3 - Clinical appearance of the luted glass fiber post

A slot was created into the root canal in order to put in the fiber post. The tooth was etched with 34.5% phosphoric acid (Vocacid™, VOCO, Cuxhaven, Germany). After beveling the post with a diamond bur and cleaning the dentinal tissues with tungsten carbide burs, the tooth was etched and the bonding agent (Scotchbond Multipurpose™ 3M ESPE, St. Paul, MN, USA) was applied to the dental surface according to the manufacturer's instructions. The fiber post (Cytac Blanco Glasfiber™; Hehnenkrat, Germany) was put in to the slot of the root canal with dual-cure resin cement (Panavia-F™; Kuraray) (Figure 3).

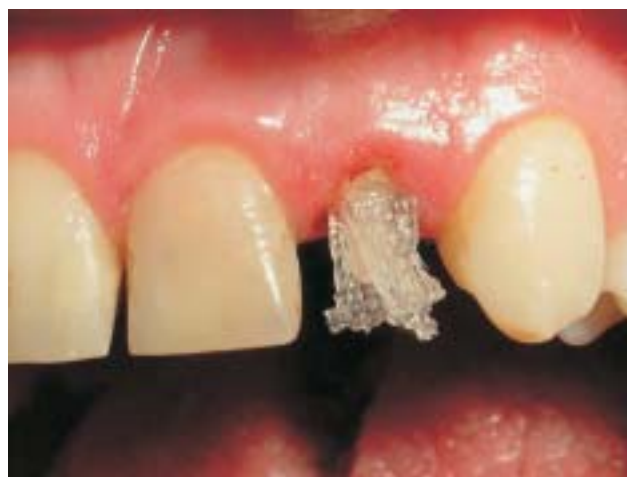
FIGURE 4 - Bonded polyethylene fiber

The coronal width and length were measured and the length of the polyethylene fibers was determined (Ribbond Reinforcement Ribbon, Ribbond Inc., Seattle, WA, USA). The ribbond was folded and cemented to the fiber post with a bonding agent (Scotchbond Multipurpose; 3M ESPE, St. Paul, MN, USA) (Figure 4). Finally, the dental restoration was completed using an incremental technique with UD, A3 and A2 shades of composite resin (Filtek Z250; 3M ESPE, St. Paul, MN, USA). Finishing and polishing procedures were performed by contouring and polishing discs (Sof-Lex; 3M ESPE, St. Paul, MN, USA) (Figure 5).

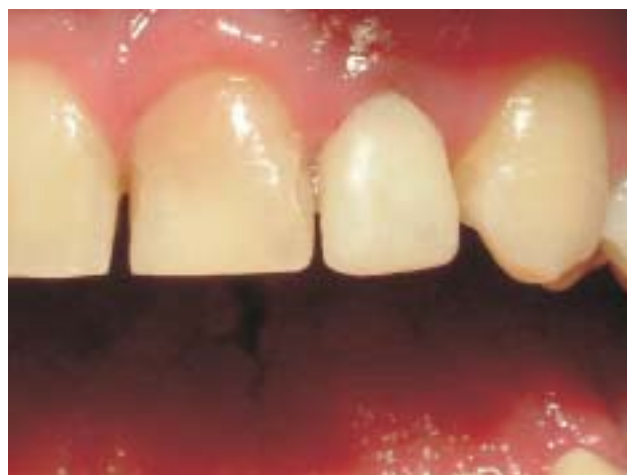
FIGURE 5 - Clinical appearance after restoration

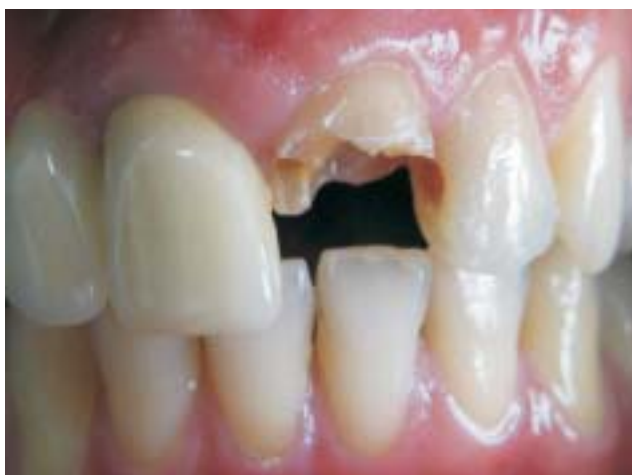
A 19-year-old male patient showed a crown fracture of the left maxillary central incisor presented to Atatürk University Faculty of Dentistry, Department of Conservative Dentistry, Erzurum, Turkey, with an esthetic complaint. During the clinical examination, a crown fracture that included enamel and dentin was diagnosed. His dental history revealed that he had a traumatic experience one year earlier. After an endodontic treatment, the tooth was restored with composite resin; however, the restoration failed (Figure 6).

FIGURE 6 - First clinical examination of the complex crown fracture

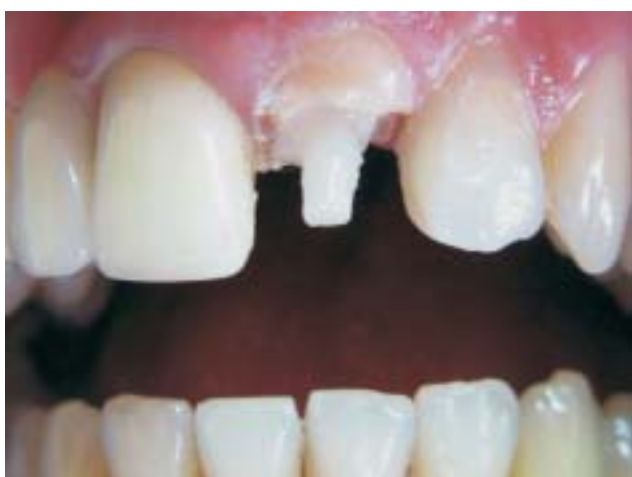
FIGURE 7 - Appearance of glass fiber post after luting

Dental tissues were beveled with a diamond bur and dentinal surfaces were cleaned with tungsten carbide burs. The root canal filling was then partially removed, leaving the apical 4 mm of the filling to maintain a good seal. All dental surface were etched by 34.5% phosphoric acid (Vocacid; VOCO, Cuxhaven, Germany) and a glass-fiber post (Cytec Blanco Glasfiber; Hehnenkrat, Germany) was placed in the root canal using a dual-curing luting system (Panavia-F; Kuraray) prior to the application of a bonding agent (Scotchbond Multipurpose; 3M ESPE, St. Paul, MN, USA) (Figure 7).

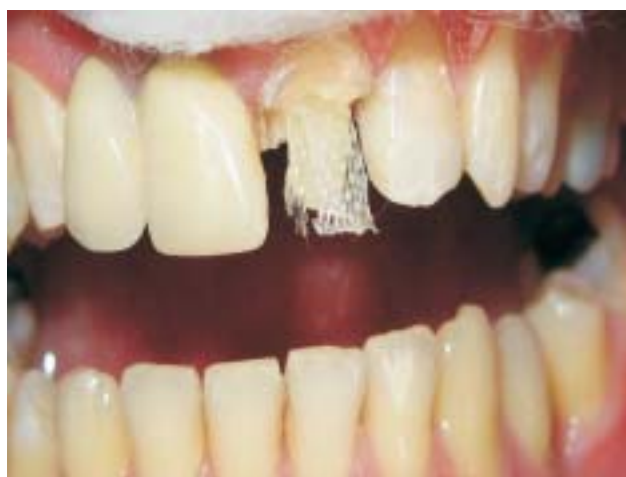
FIGURE 8 - View of polyethylene fiber bonded to the glass fiber

The ribbon was prepared as described in case I (Figure 8). The restoration was completed with a universal composite resin (Filtek Z250; 3M ESPE, St. Paul, MN, USA) according to the incremental technique using UD and A2 shades. Finishing and polishing procedures were performed using sof-lex contouring and polishing discs (Sof-Lex; 3M ESPE, St. Paul, MN, USA) (Figure 9).

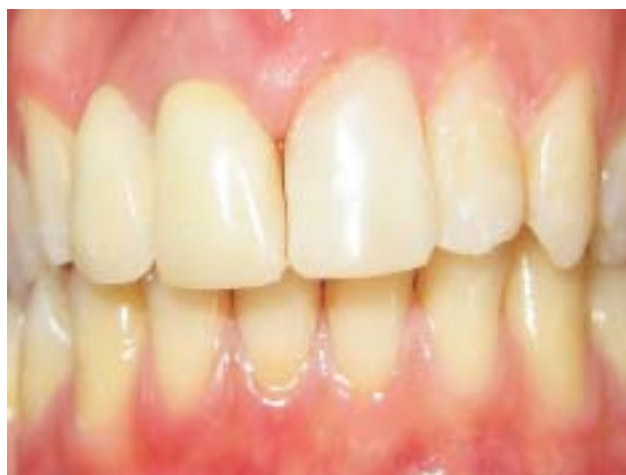
FIGURE 9 - Final restoration for case 2
